Metallurgical Laboratory Report

I. **Stainless Steel 409 (1.4512)**

I. Stainless Steel 409 (1.4512)

II. Stainless Steel 18% Chromium/8% nickel

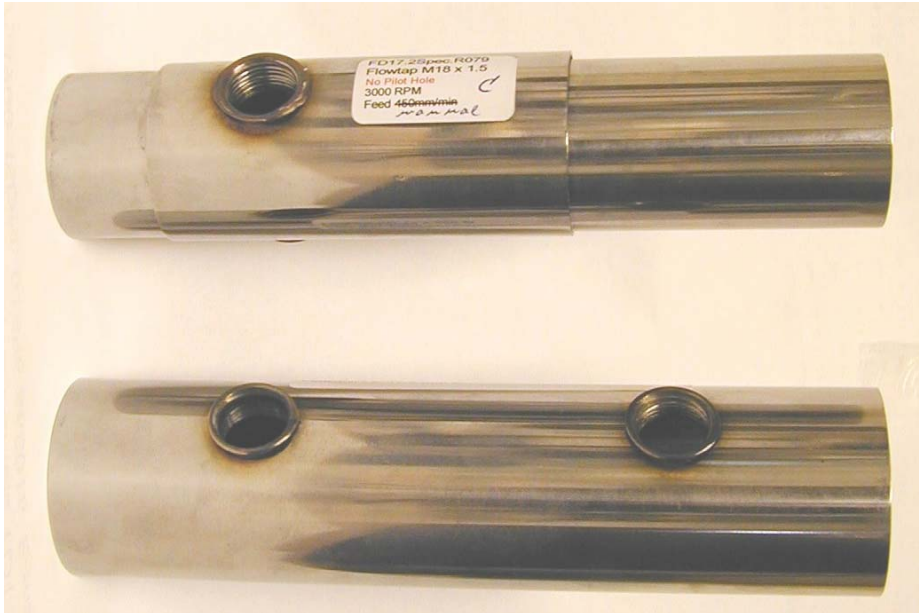
The photographs below illustrate the “as-received” 2-off seam welded tubes, one double-skinned, submitted for metallurgical evaluation of Flowdrilled holes. Each tube contained Flowdrilled holes identified as follows:

SAMPLE A- Stainless Steel 409 – 50.8mm OD * 1.5mm wall thickness

SAMPLE B – Double-skinned Stainless Steel 409 – Inner tube= 42mm OD * 1mm wall thickness;

1-off Flowdrilled Hole “B”

1-off Flowdrilled Hole “C”

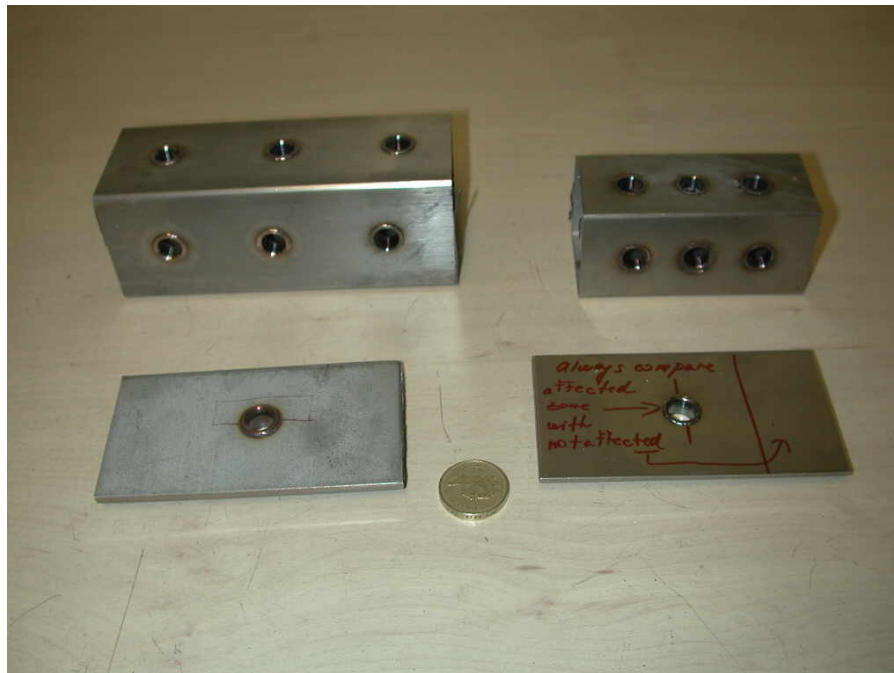
Fig 1. General photograph showing the range of Flowdrilled samples submitted for Examination

- A) Plate - 100 * 54 * 2 mm thick
- B) Plate - 100 * 53 * 3mm thick
- C) Small Box Section - 40 * 40 * 80mm long * 1mm thick
- D) Large Box Section - 50 * 50 * 133mm long * 2mm thick

The Flowdrilled holes were approx 10mm diameter with an approx 5mm long tapered extruded tail on the exit side of the Flowdrilled holes. Detailed dimensional examination was not carried out.
